RE: 2021 Sanitary Survey Report

SANITARY SURVEY REPORT

Waterfall Community WUA NM3564319

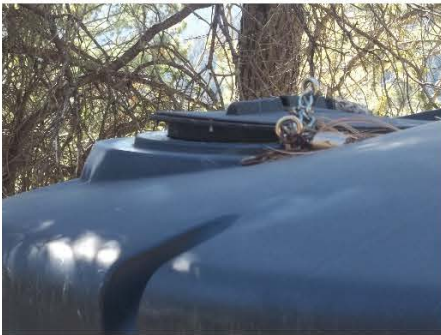
Photo Documentation:

1. **Significant Deficiency Code:** 001Q- Storage facility is not secure from elements

Regulatory Citation: 20.7.10.400.D

Significant Deficiency Description: The 3000-gallon polyethylene Storage Tank #4 (008) hatch does not create a water-tight seal.

Required Corrective Action Plan: The Waterfall Community WUA must submit a written Corrective Action Plan to DWB within 30 days of the sanitary survey cover letter date.

Required Corrective Action: The Waterfall Community WUA must submit a photograph or other documentation acceptable to DWB, indicating that the hatch is watertight and flush with the opening.
